20 June 2006

## Report on Façade Examination

515 Edgecombe Avenue

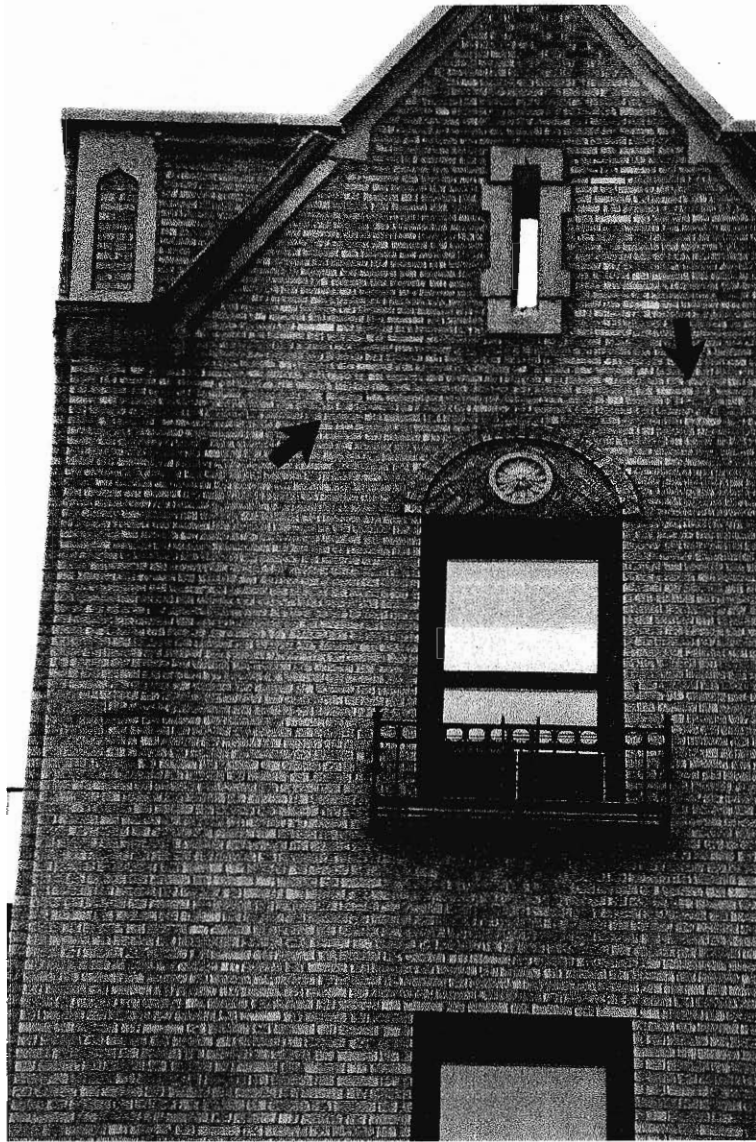
1. The first column of windows at the south end of the Edgecombe façade, just below the parapet at the peek detail, there are several open mortar joints and some spalled brick. These should be repaired to limit water infiltration. See photograph no. 1.

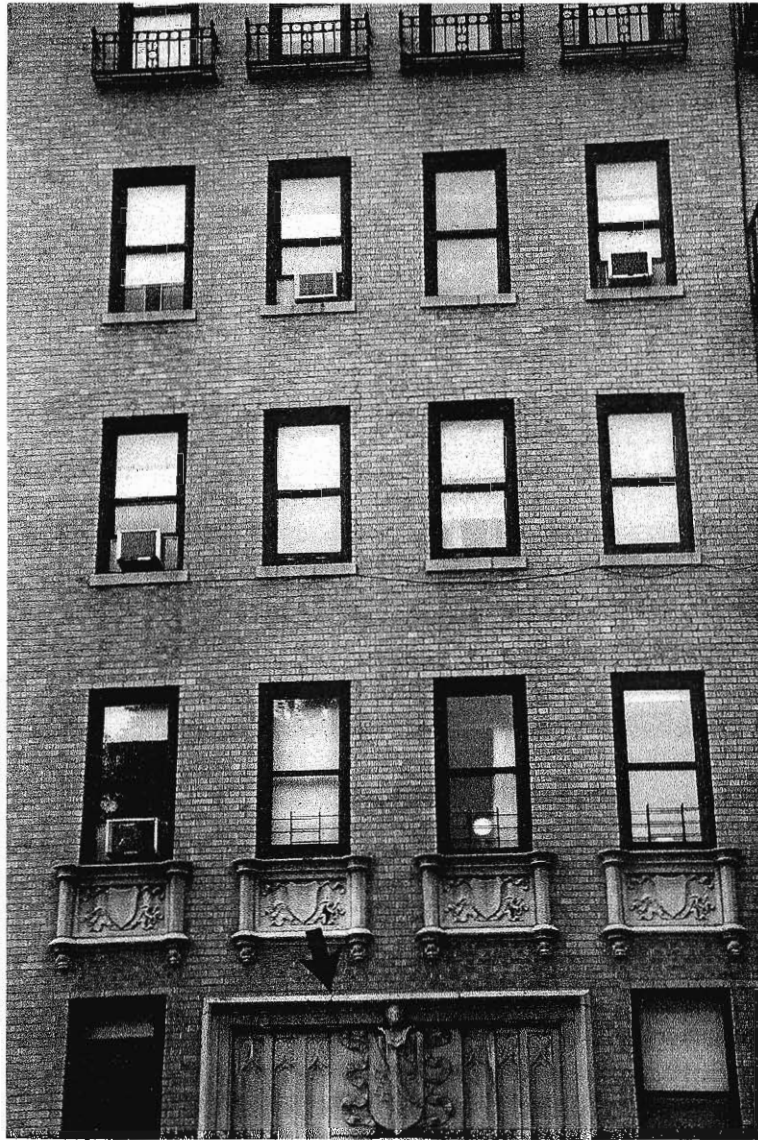
5. At the decorative stone trim around the lobby entry doors, several mortar joints are open or have loose mortar. Loose mortar should removed. Open joints should be cleaned and all joints re-grouted. See photograph no. 2.

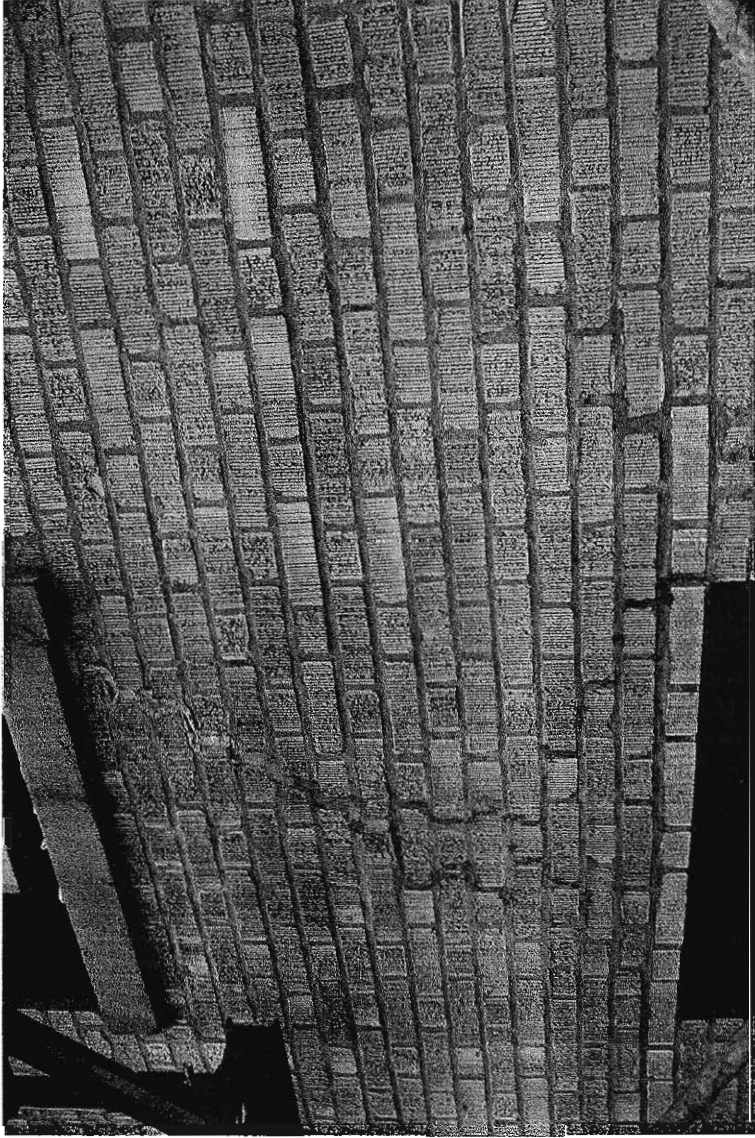
7. Repair work to the northeast corner of the building was completed at the time of our inspection. Several cracks both in the brickwork and the stone sills appeared to have been patched. The type of repair work or the extent of the work just completed versus work that had been completed previously could not be determined. Also, the type of repair or remedial work could not be determined. See photograph no. 3.

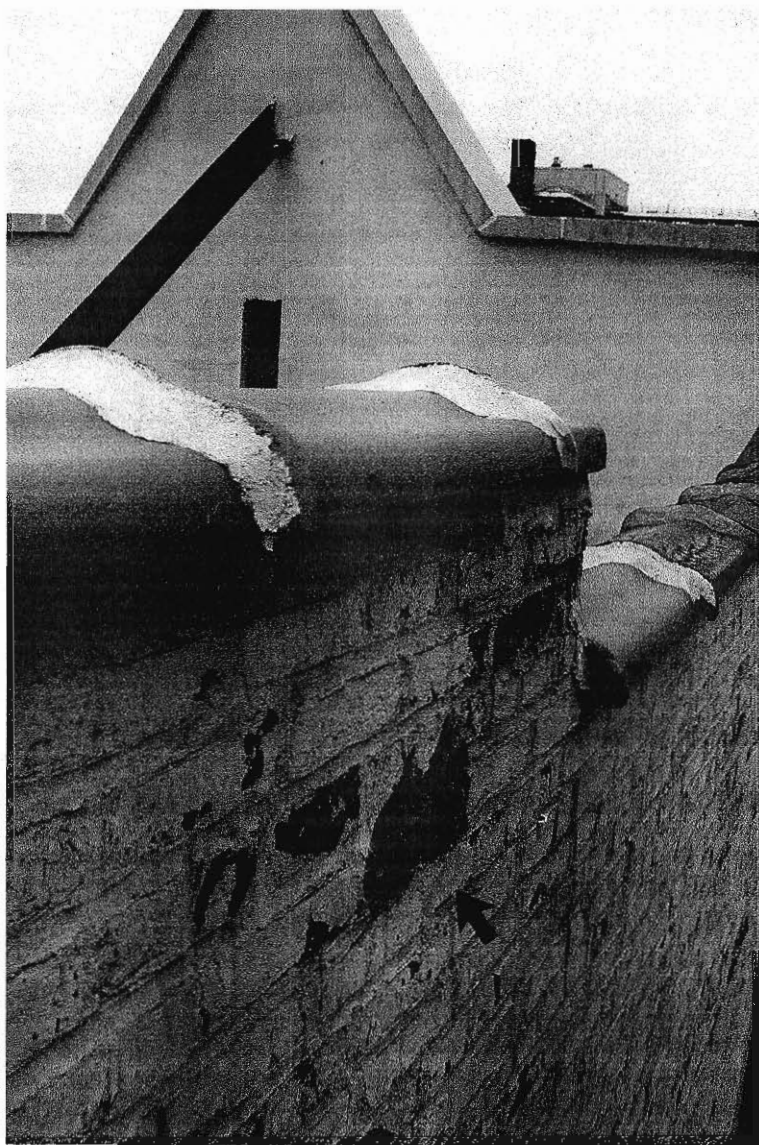
8. The south elevation brickwork had previously been painted. Areas of paint have been weathered off. Also, in several locations, the surface of the brick has spalled. The damaged bricks should be cut out and replaced to minimize water infiltration. See photograph no. 4.

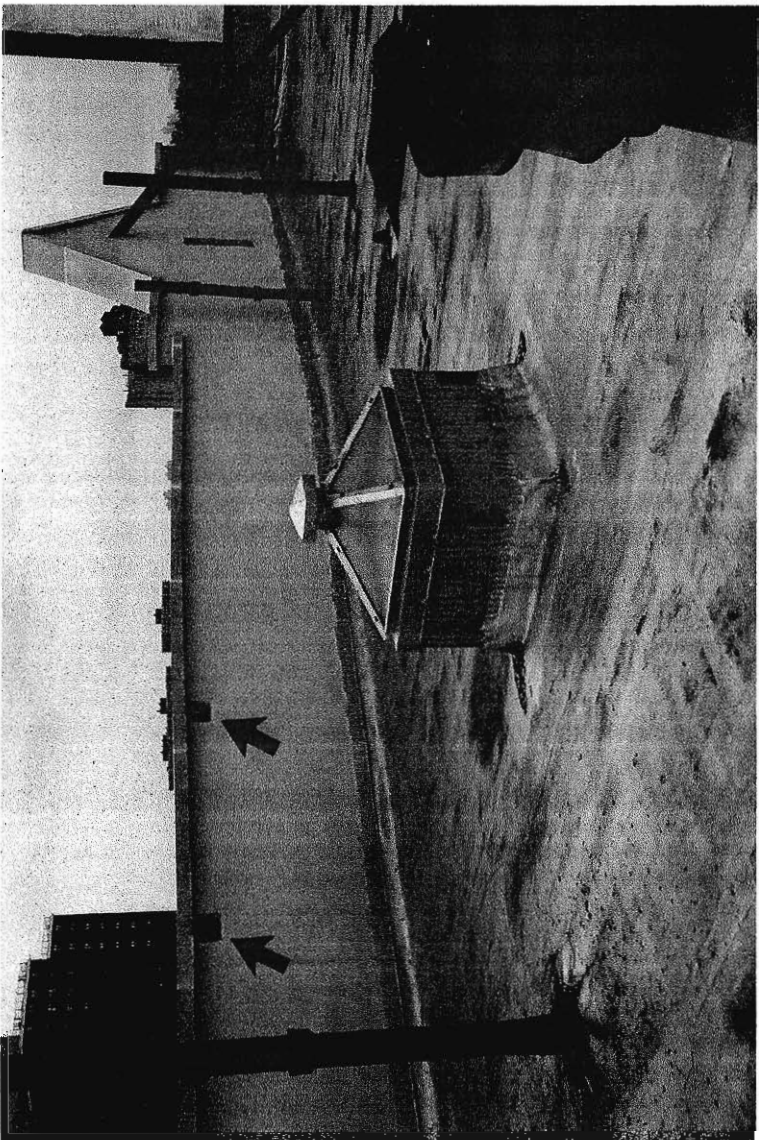
10. The east parapet wall is generally in good condition. Where decorative openings in the parapet occur and at changes in parapet height, the parge coat in many locations is loose or cracking. Loose material should be removed, the area cleaned, and new parge coat applied. See photographs no. 5 and 6.

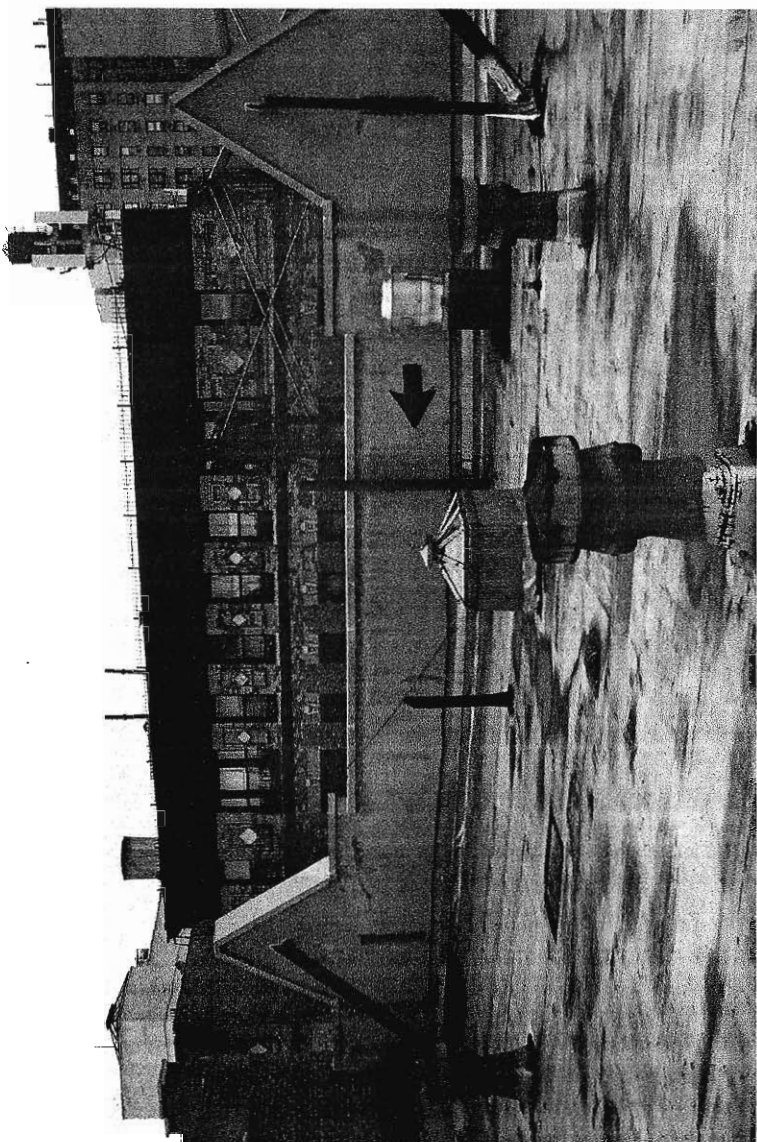
7

11. The north parapet wall between the high peak shapes shows signs of movement and requires investigation. As some repair work has previously occurred, it is not possible to determine the seriousness of the situation. As the parapet has a bow inward, because of the fact that areas have been patched, the cause of the movement or the extent of the problem is not visible. This area requires exploratory work to determine the cause and seriousness of the problem. See photographs no. 7, 8 and 9.

Of special concern is the condition of the north parapet. As noted in the report, the parapet has a lean inward. Whether this is new or was present over time is not known. As surface repair work has been performed, it is not possible to see any movement cracks or other indications as to the underlying problem. This areas requires exploratory work to determine the seriousness of the condition.
